PROPERTY INSPECTION REPORT

Property Inspected: **456 Main Street
Hometown, PA 15000**

Prepared For: **Jane Doe**

Inspection Date: 2014

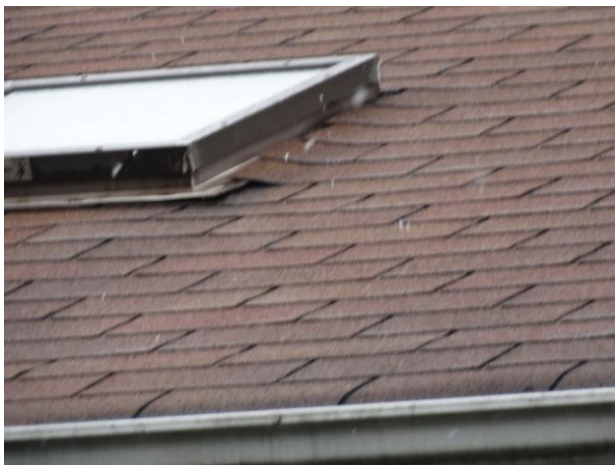
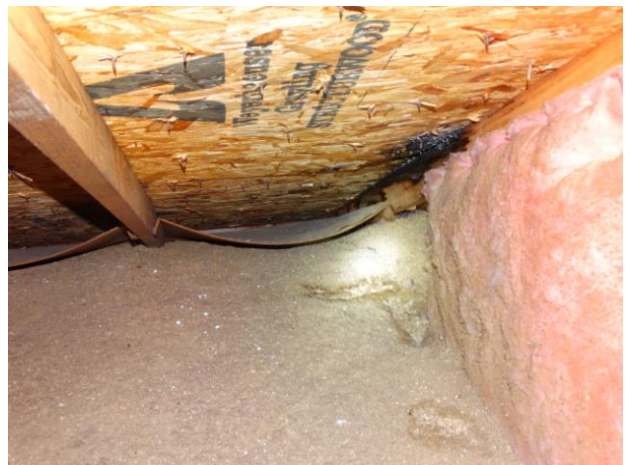
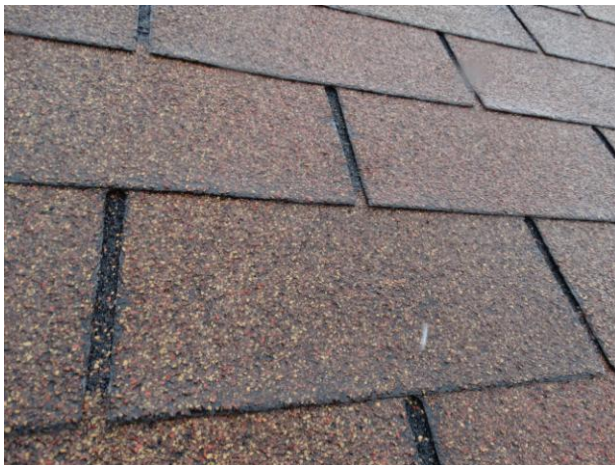
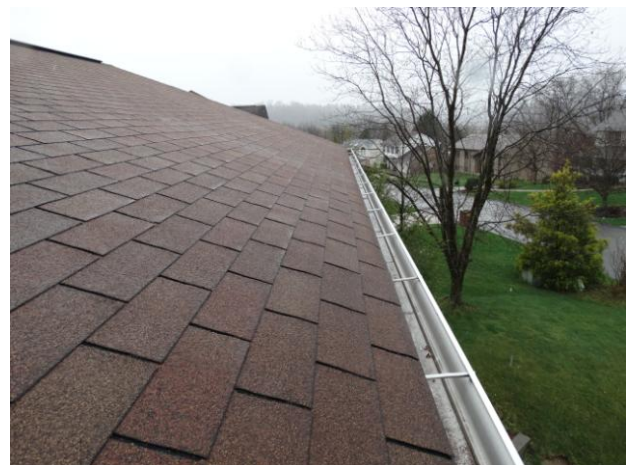
A roof leak was observed in the attic. The leak was at the skylight. See picture below.

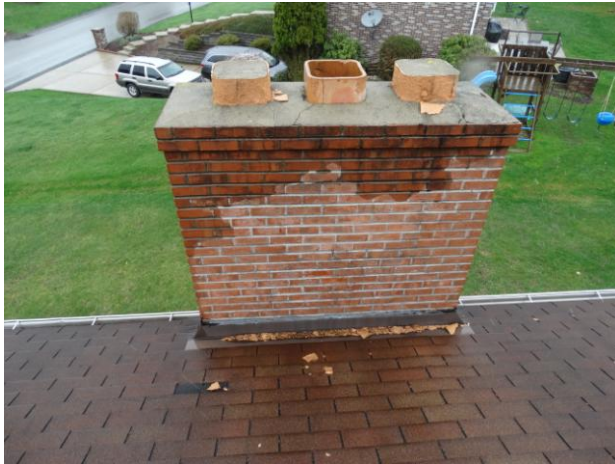
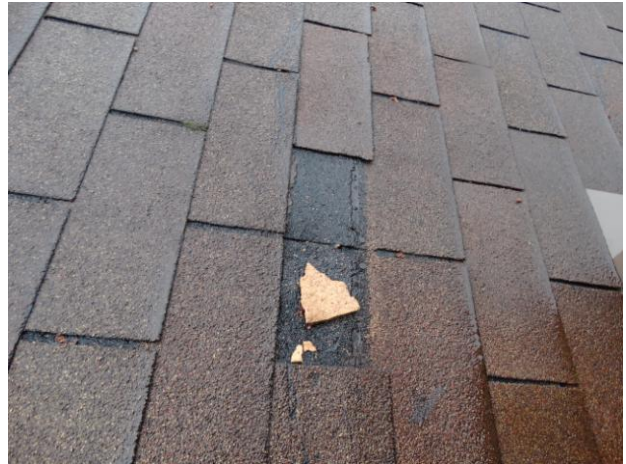
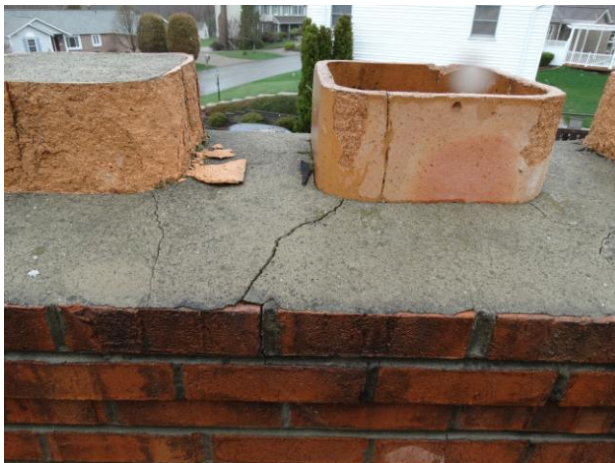
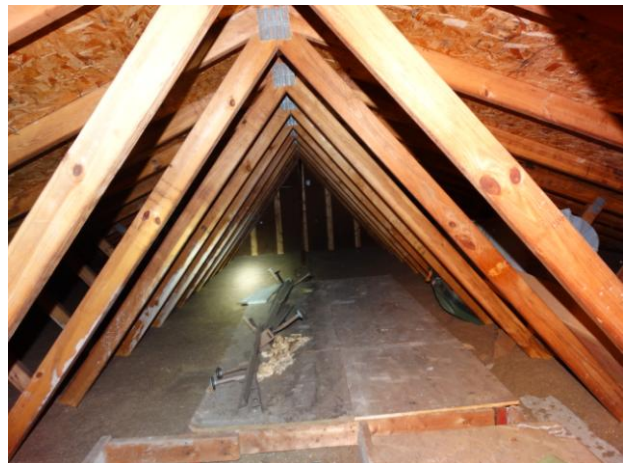
A shingle was missing from the lower left roof. The missing shingle should be replaced.

There were cracks in the concrete crown on the top of the chimney. The cracks should be sealed to prevent further deterioration of the crown. The crown protects the bricks near the top of the chimney.

The chimney flue was not equipped with an animal screen or a rain shield.

A qualified roofing contractor should make all necessary repairs to the roof.

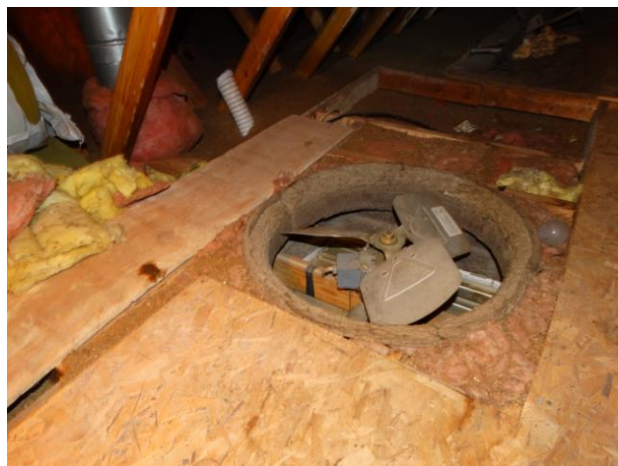
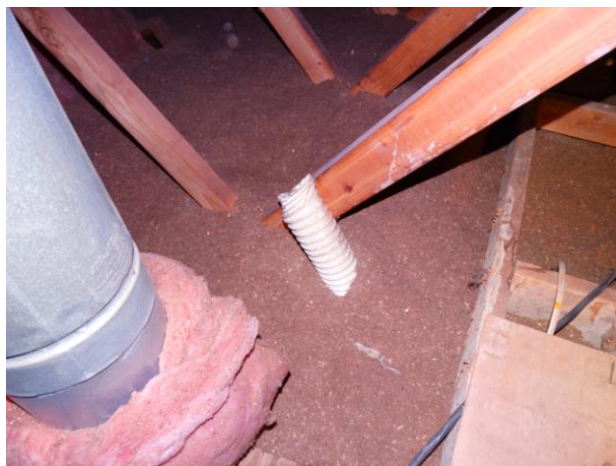
The exhaust fan for a second-floor bathroom discharged into the attic. This could cause humidity and mold problems. There was no obvious visible evidence of mold. Pittsburgh Home Inspections, Inc. does not test for mold. It is recommended that the exhaust fan be discharged to the exterior, or to the nearest roof vent.

The whole house attic fan was operated. When the fan is in use several windows must be left open. Operating the fan with the windows closed can result in carbon monoxide back-drafting into the home from the water heater chimney.

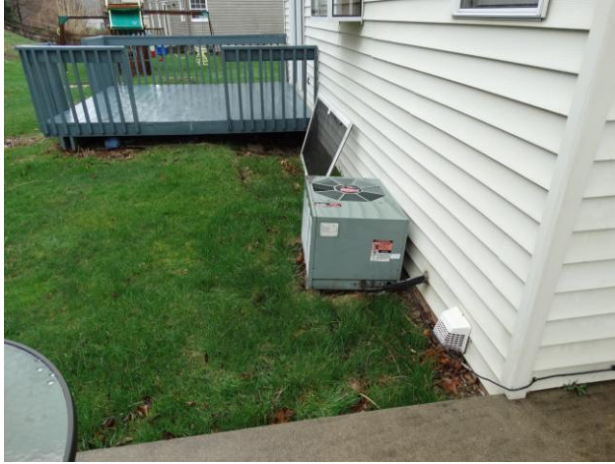
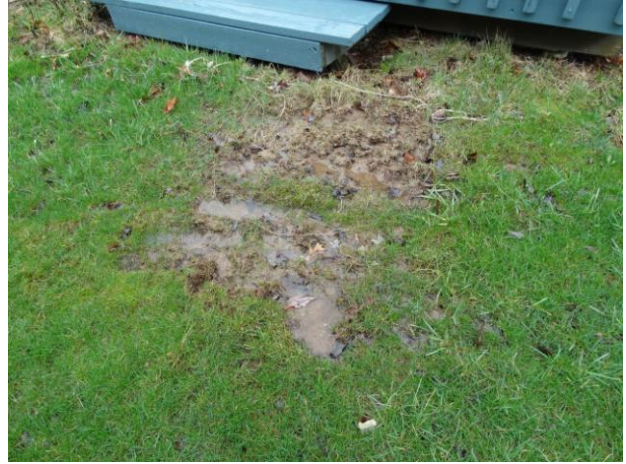
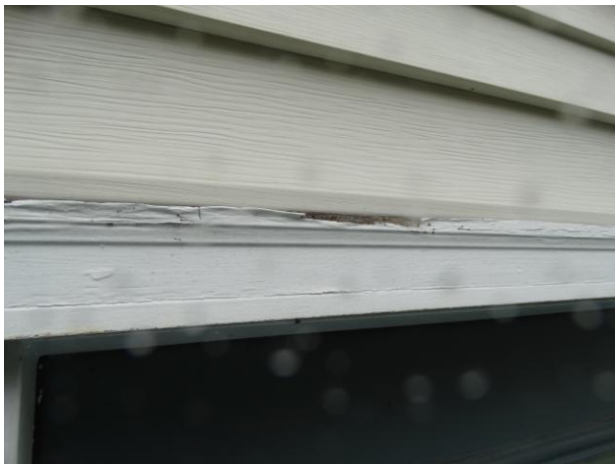
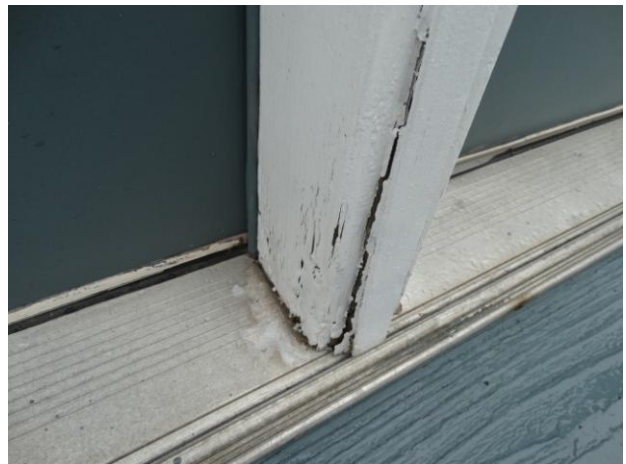
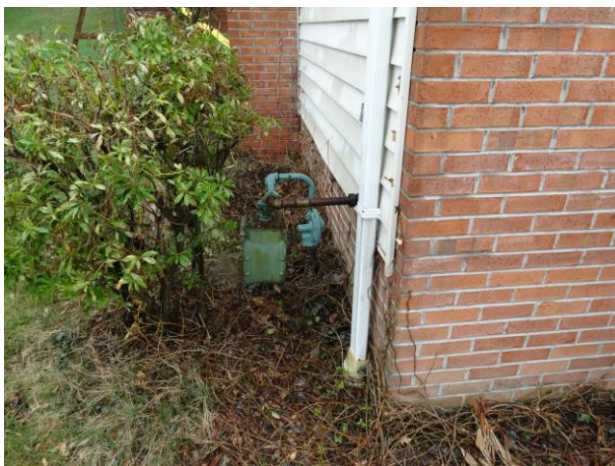
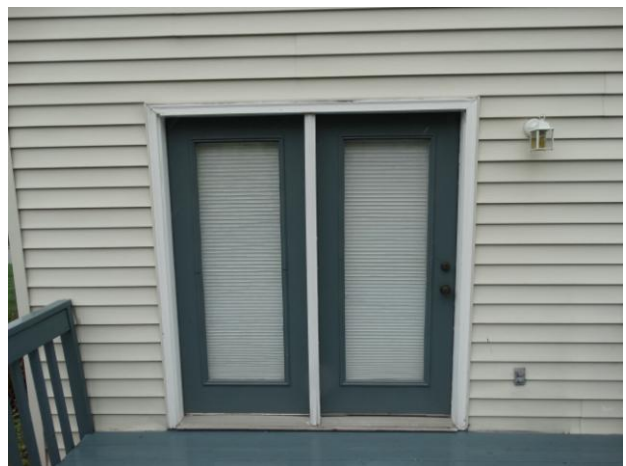
The surface grading next to the front and left side of the home was not adequate for directing surface water away from the foundation. The condition is common for a home this age. It is generally recommended that the grading within 3 feet of the foundation on all sides should slope away from the home at least 1 inch per foot. Surface water that soaks into the ground near the home can seep into the basement through the foundation. See pictures below.

The wood trim around both rear doors was soft and rotted in places. The wood trim should be repaired or replaced as needed, and should then be painted. See picture below.

There was standing water in the rear yard near the deck. Installing a French drain in the rear yard may help this problem. See picture below.

The exterior condensing unit for the air conditioner was not level. The unit should be made level. See picture above in exterior comments.

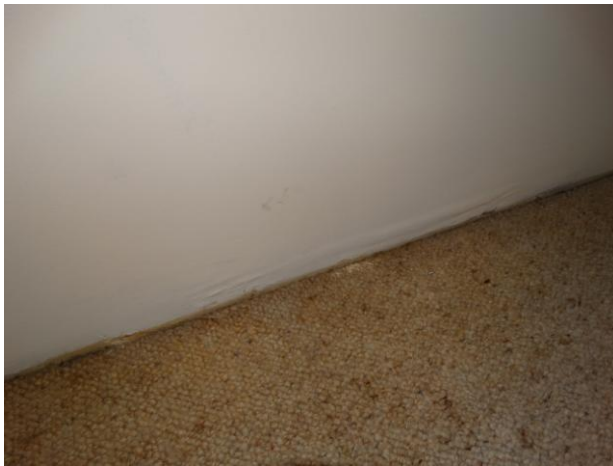
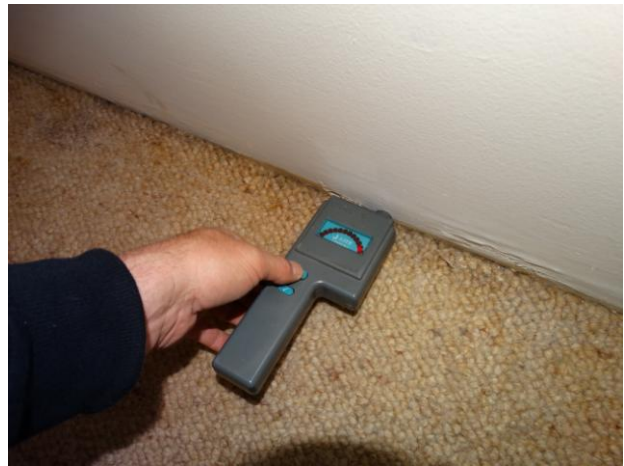
The bottom edge of the drywall in the finished area of the basement was checked with a moisture meter. Elevated levels of moisture, 25 to 30%, were detected near the bottom edge of the drywall along the left foundation wall. The moisture was from foundation seepage. Wood, drywall, and carpeting that are above 20% moisture on a regular basis are susceptible to deterioration and mold. The moisture problem should be corrected.

Basement moisture seepage is best prevented from the exterior if possible. All roof and surface water should be controlled and directed away from the foundation. Controlling seepage could involve some combination of controlling roof and surface water, installing an interior drain and sump pump system, installing an exterior French drain, operating a dehumidifier.

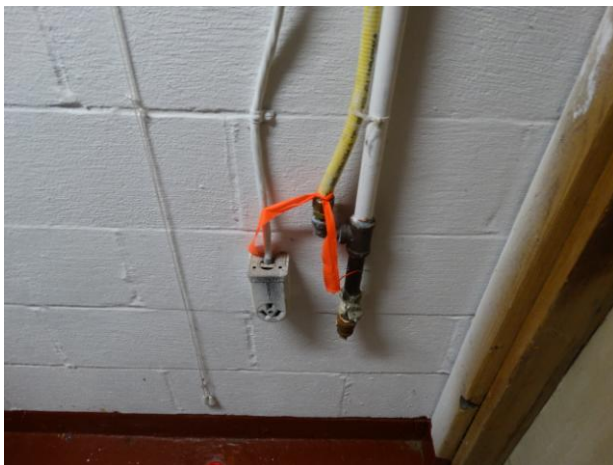
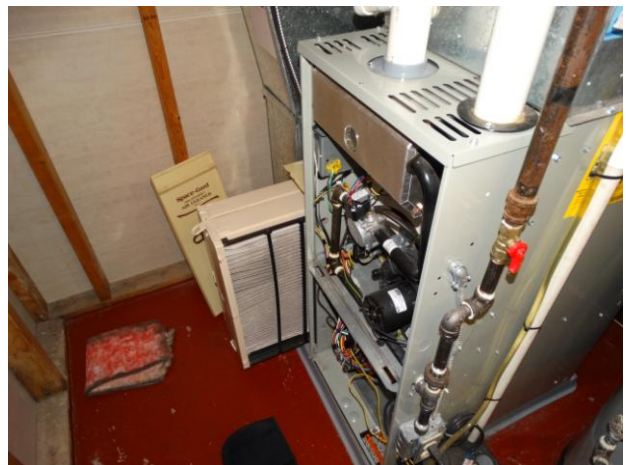
The furnace filter was somewhat dirty. The filter was a high efficiency disposable and does not need to be replaced as often as a regular disposable filter. The filter should be replaced now and approximately every 6-12 months. See picture below.

A Tif 8800 combustible gas detector was used to test accessible interior gas lines. A gas leak was detected at a pipe connection in the basement. The leak was marked with orange plastic tape.

A qualified plumbing contractor should repair the gas leak.

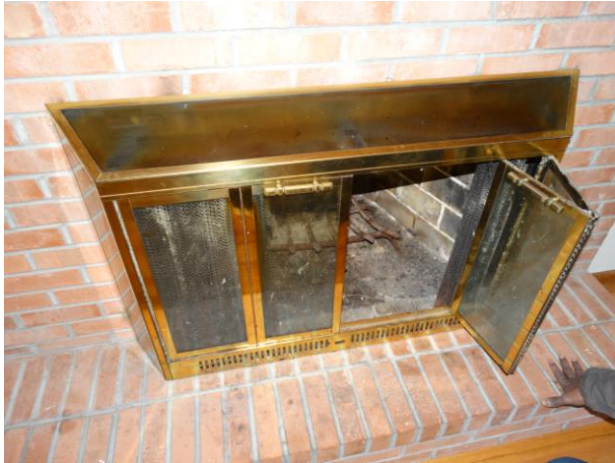
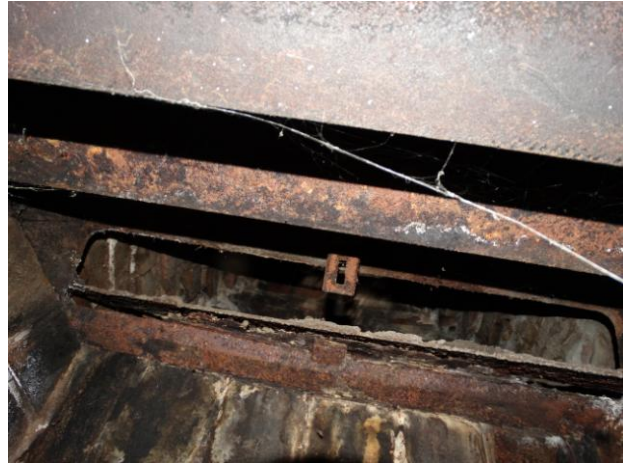
The fireplace chimney was not equipped with a rain cap. The fireplace damper was severely rusted and the damper handle was broken off. A qualified contractor should make all necessary repairs to the damper. As discussed in the inspection, installing a vent-free gas log-set should be considered.
